# OC VIEW

MARCH / APRIL 2017  
[WWW.CAIOC.ORG](http://WWW.CAIOC.ORG)

## IS THAT BALCONY A DEATH TRAP?

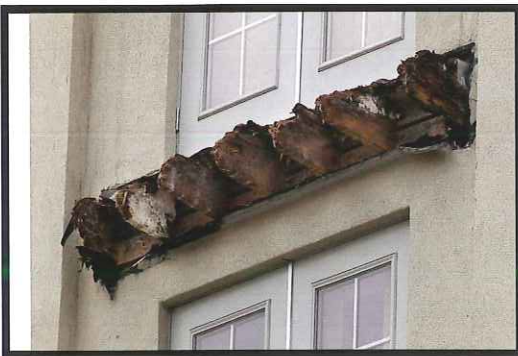
Damage found to structure following the Berkeley collapse in June 2015.  
Image: Jeff Chiu/Associated Press

to make a thorough inspection of the balcony and all of the waterproof connections. Poor construction methods as well as lack of maintenance can lead to severe wood decay, which can occur in just a few years.

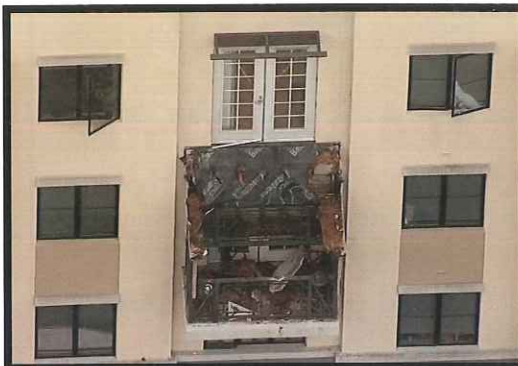
Berkeley Balcony Failure (CBS)
